Architectural Effects on Impact Resistance of Uncoated MI SiC/SiC Composites

**R.T. Bhatt, L.M. Cosgriff, and D.S. Fox
NASA Glenn Research Center
Cleveland, OH 44135**

**Paper prepared for presentation at the PACRIM-8 conference to
be held in Vancouver, Canada, May 31 to June 4, 2009**

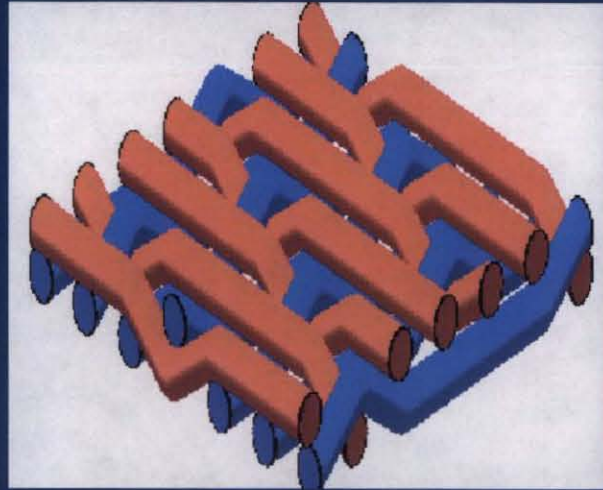
(a) Harness satin weave

Composite characteristics : BN/SiC coated Hi-Nicalon-S SiC fibers, 8 ply, 0/90, 5HS Weave, 18 epi and 2 different 2.5D woven structures, Melt infiltrated (MI) matrix.

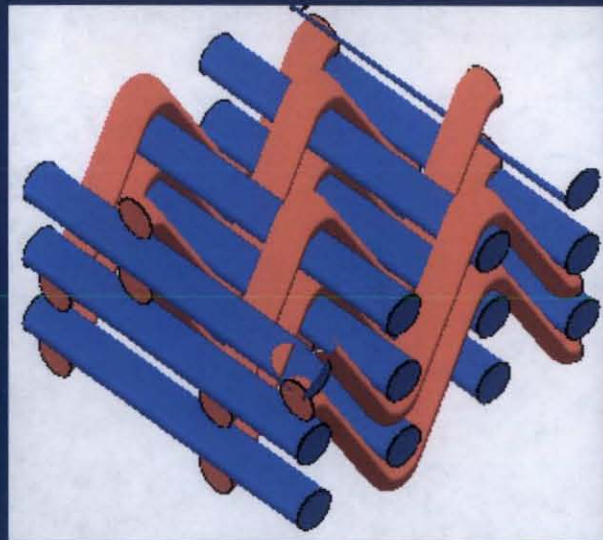
(b) Layer angle interlock

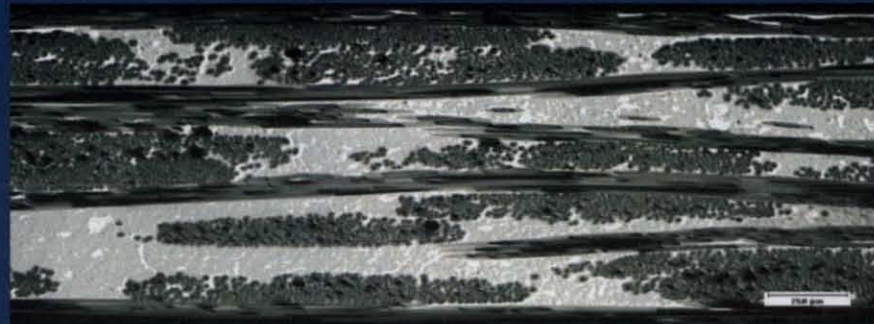
Optical Photographs of the Cross Section of 2-D and 2.5D MI SiC/SiC Composites

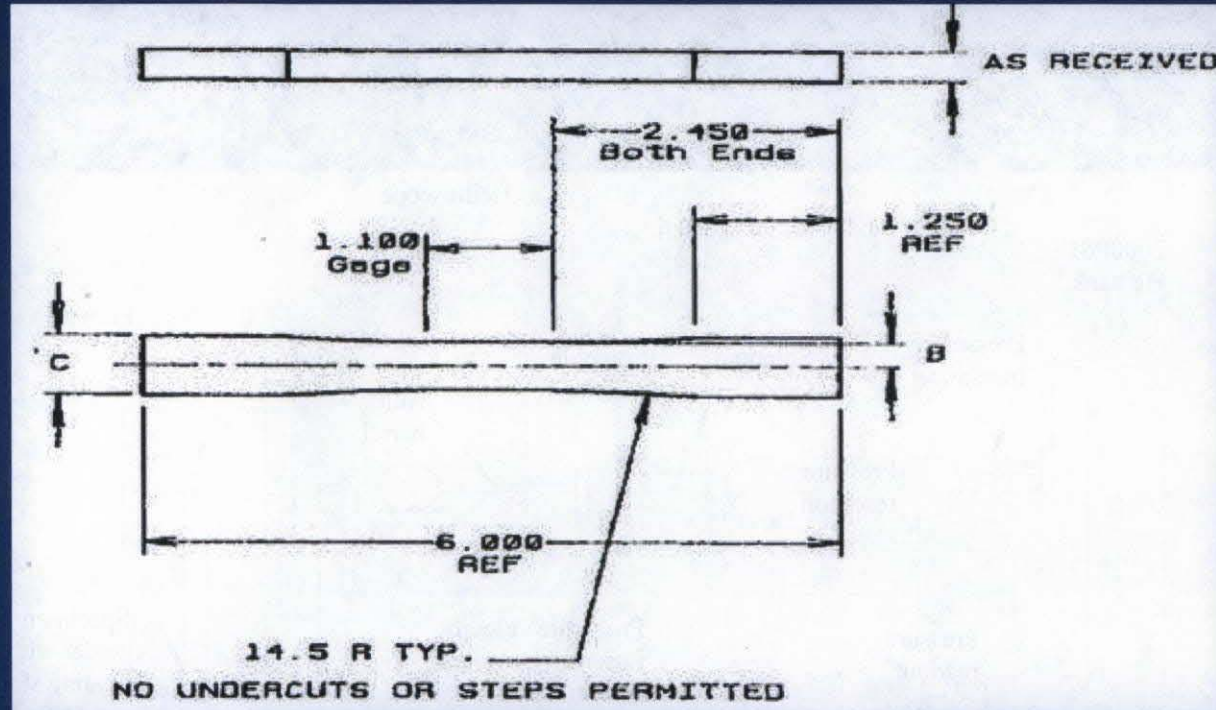
Impact Specimen Geometry

Note: All dimensions are in inches

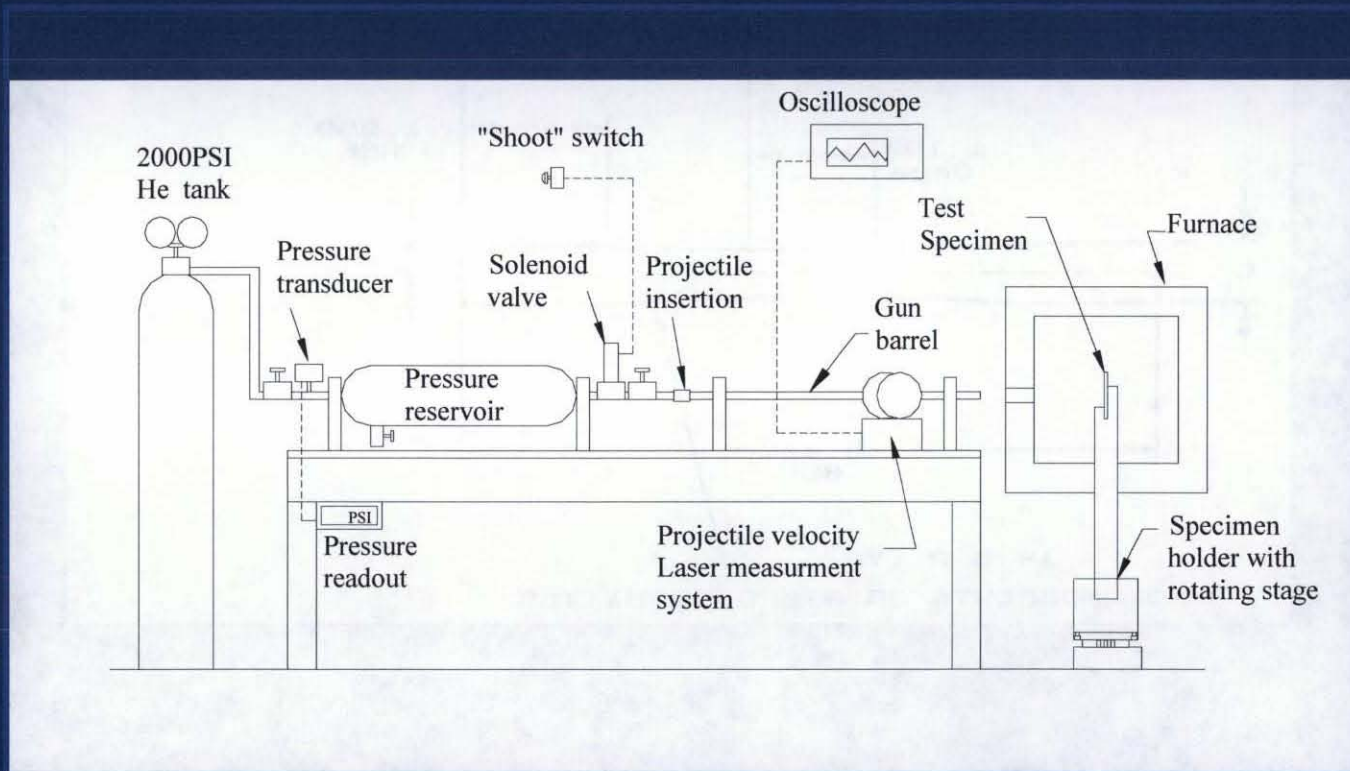
Impact Facility

High-temperature capability up to 1500°C

- Projectile: 1.59mm dia steel balls

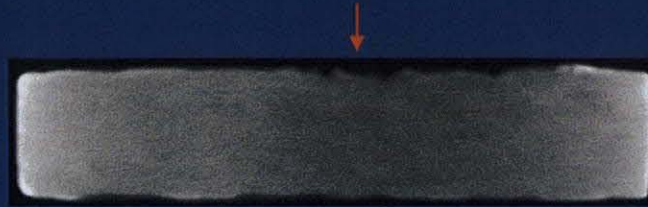
115 m/s

CT Images of 2-D MI SiC/SiC Composites Impact Tested at 1316°C in Air

- Both 2-D and 2.5D composites show increase in surface and volumetric damages with increasing impact velocity. However, 2-D composites are prone to delamination cracks.
- In both 2D and 2.5D composites, the magnitude of impact damage at a fixed impact velocity is slightly greater at room temperature than at 1315°C.
- At a fixed projectile velocity and test temperature, the depth of penetration of the projectile into the substrate is significantly lower in 2.5D composites than in 2D composites.

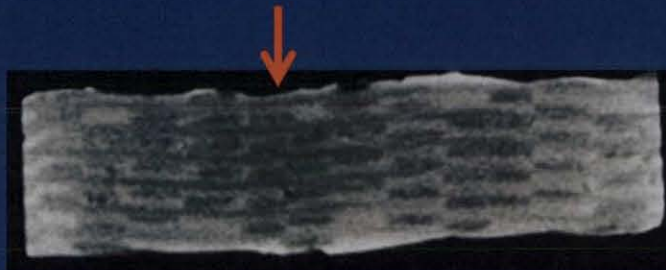
115m/s

CT Images of 2.5D (Type II) MI SiC/SiC Composites Impact Tested at 1316°C in Air

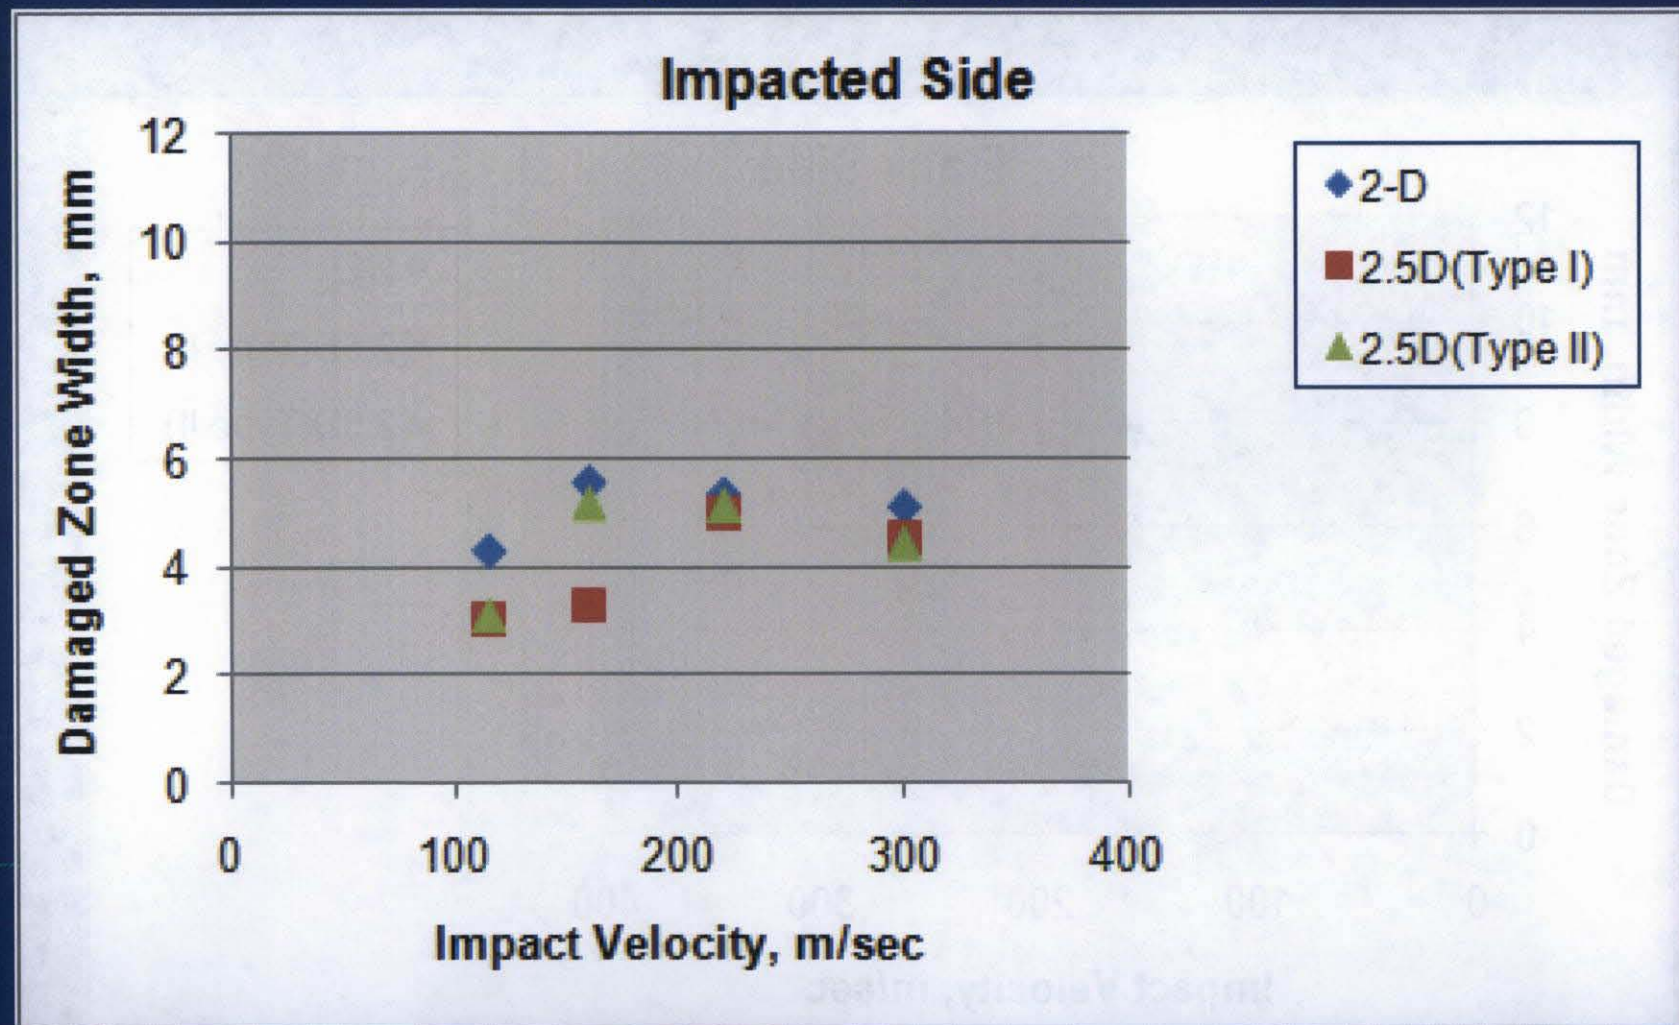
Comparison of Damage Zone Width with Projectile Velocity for 2D and 2.5-D MI SiC/SiC Composites Impact Tested at 25°C In Air (Thermography Data)

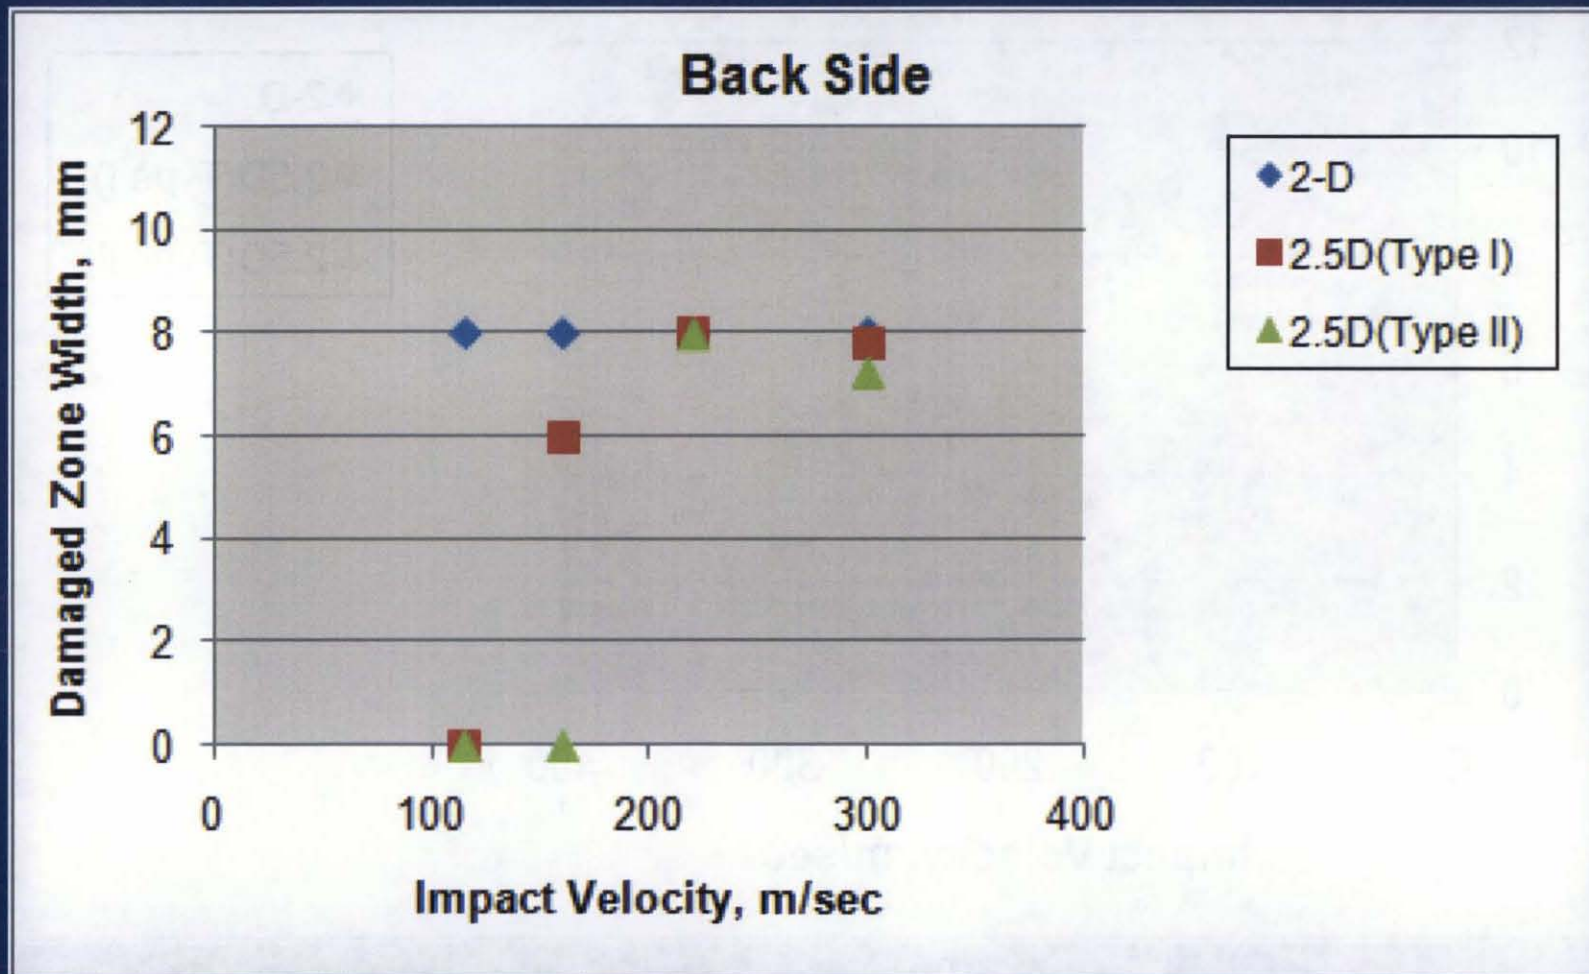
Comparison of Damage Zone Width with Projectile Velocity for 2D and 2.5-D MI SiC/SiC Composites Impact Tested at 1316°C In Air (Thermography Data)

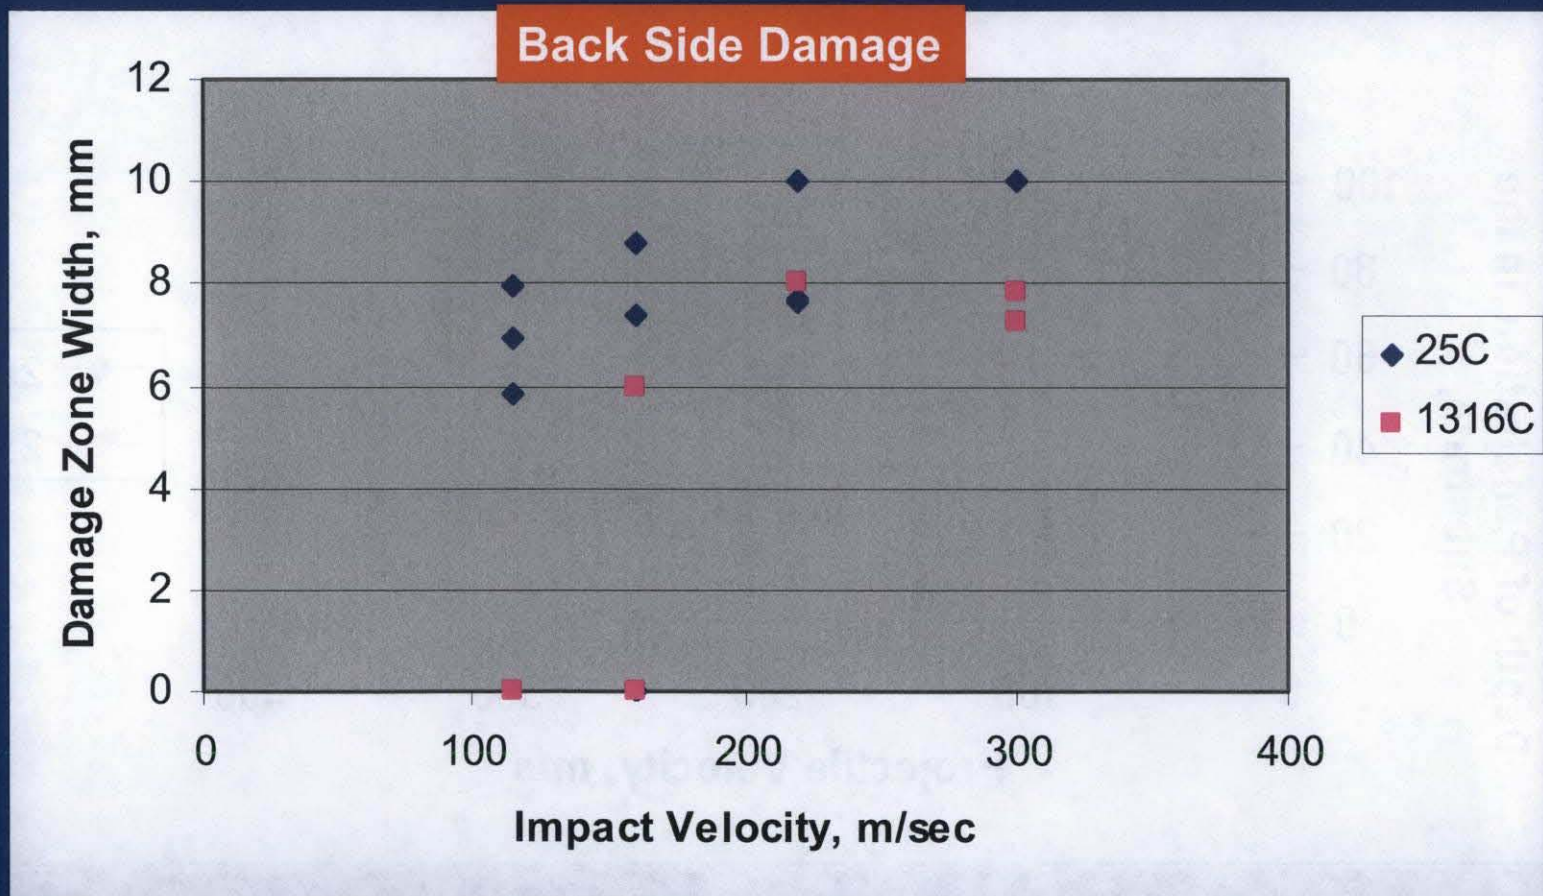
Comparison of Damage Zone Width with Projectile Velocity for 2.5-D (Type I and II) MI SiC/SiC Composites Impact Tested at 25⁰ and 1316⁰C in Air (Thermography Data)

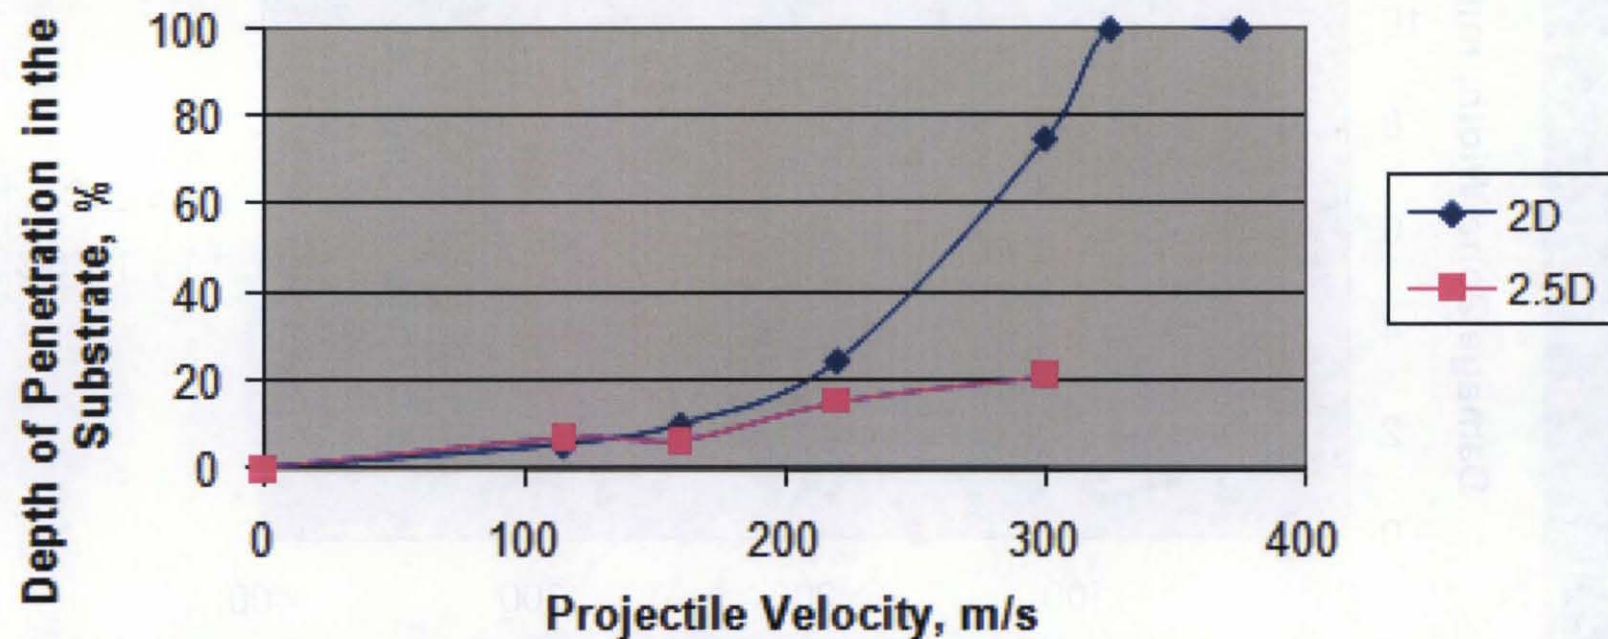
Variation of Damage Zone Depth with Projectile Velocity for 2-D and 2.5D MI SiC/SiC Composites Impact Tested at 1316°C in Air (CT Data)
